Update on the Blockley Church refurbishment project - October 2019

Robert Burch

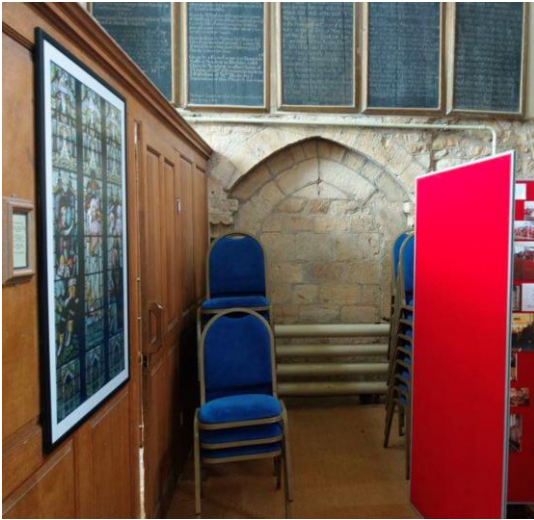
The blocked-off access into the tower. - Small pointed arch within a larger pointed arch which replaced an original Norman rounded arch!

An exciting part of the project has been the examination of the blocked-up archway between the nave and the tower by an archaeologist and a structural engineer. Advice received is that the archway could be re-opened so that the large room in the base of the tower can be put to good use.

Close examination of the archway reveals the changes that were made since the 12th century as towers came and went, a gallery was added at the rear of the nave and then removed and archway styles changed. It seems that a drawing in the Smeeton book about the church is incorrect as the full-width rounded arch was unlikely to ever have been open when there was a tower. The archway is in poor condition on the tower side probably due to excavation in the early 20th century in a failed attempt to reopen the arch.

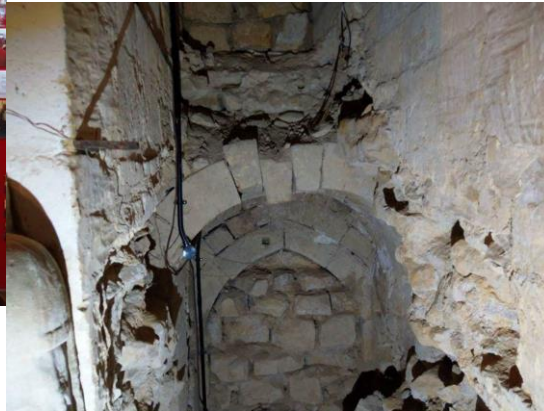
From the tower side, it is a mess and needs work to stabilise it.
